Rhynie Symbol Stones

Conservation Assessment Report

March 2020

John Renshaw Architects & Spectrum Heritage

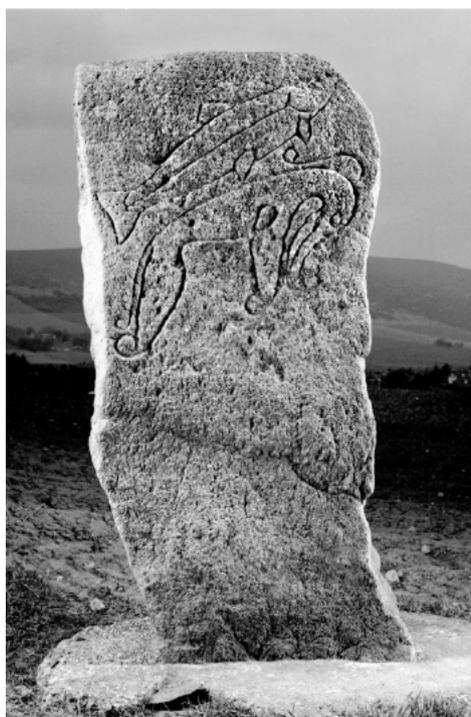
3.2 Craw Stane (Rhynie 1)

The carved surfaces of the stone appear to be generally in fair condition and the stone is relatively durable.

A significant crack extends horizontally across the shaft at about a third above ground level. The carved surfaces of the stone are covered by algae and lichens.

- The symbol stone (Rhynie 1) is particularly exposed to the natural environment due to its orientation and elevation. The southerly aspect will subject it to significant fluctuations in temperature and it is very exposed to prevailing winds and rainfall.
- The carved surfaces are covered with lichens and algae, as well as soiling which relate to the environmental conditions, possibly to time when the stone was in contact with or under the ground and rubbing by livestock.
- There is a significant fracture visible on the southern and western elevations of the symbol stone which may compromise its structural integrity.
- There may be a risk that long term effects of thermal stress developing between the concrete base and the stone could cause damage.
- The symbol stone is also vulnerable to damage by livestock which are currently free to shelter behind it or rub against it.

The Crow Stane is exposed to the natural environment and will continue to deteriorate and lose definition of the carved symbols; climate change will accelerate these decay mechanisms. The symbol stone is also currently at risk from damage from livestock.

- Commission a stone conservator to carry out detailed condition survey of the carved surfaces and the stone and provide recommendations for its long term preservation;

- Implement any conservation treatments which are recommended by the stone conservator, which may include the removal of the lichen and other biological growths.

- Other interventions which may merit consideration as part of the condition assessment may include the benefits of providing a shelter to reduce the rate of decay of the carved surfaces or the relocation of the stone to a secure and stable environment and replacement on the site with a high quality facsimile;

- In the short term and subject to the recommendations of the condition survey, the feasibility of providing a stock proof enclosure around the Crow Stane and Scheduled Monument Area should be investigated;

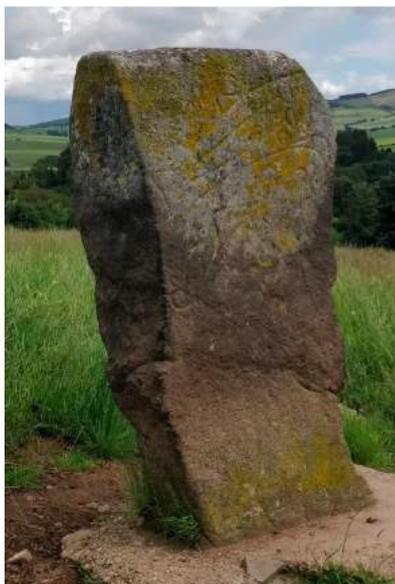
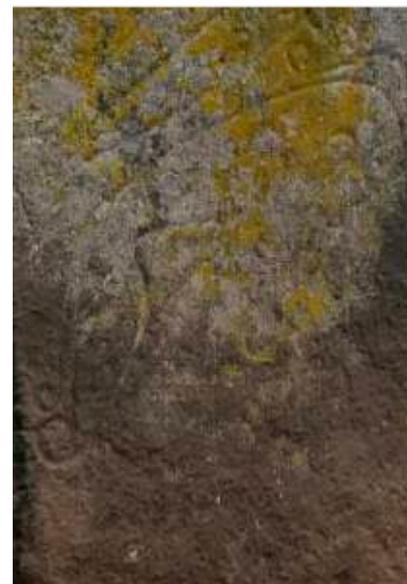
Photographs of Rhynie 1, 19 July, 2019

The ground around the concrete base is eroded possibly due to poaching by cattle.

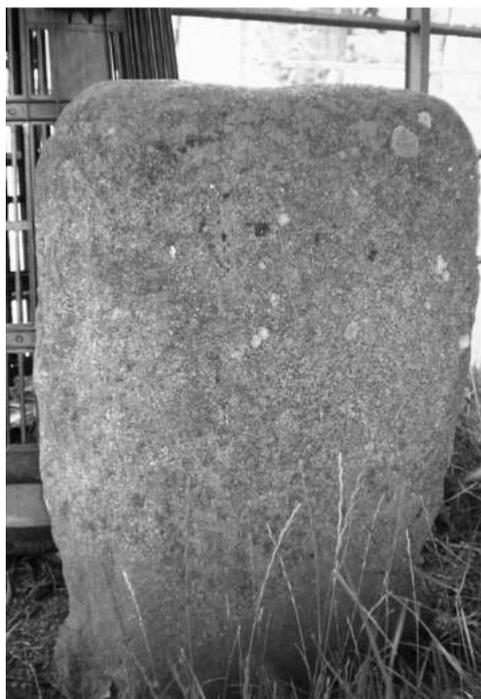
Rhynie 2 is a granite boulder, measuring 0.59m x 0.48m x 0.19m; hardly any trace of the original carving survives.

Photograph of Rhynie 2, 1996 RACHMS online photograph , <https://canmore.org.uk/collection/337028>

It is recorded that the symbols incised on Rhynie 2 comprised a double disc and z-rod above a crescent and V-rod. Rhynie 3 was incised with the figure of a man with a shield and a horseshoe or arch composed of five parallel arcs. The figure was shown walking from right to left, wearing a cloak, holding a ball-ended staff (probably a spear) in his left hand and carrying a small rectangular shield.

- The priority for the conservation of Rhynie 2 & 3 must be to preserve what little remains of the carved surfaces. Given the nature of their current condition it is considered unlikely that any surviving surface detail will survive in the short - medium term if they remain exposed to the external environment.

These two symbol stones are in such poor condition that any surviving traces of the original carvings will be lost if they remain in an external environment. Their poor condition combined with the absence of any interpretation makes it difficult or impossible to understand and appreciate their cultural significance.

- Commission a stone conservator to carry out detailed condition survey of the carved surfaces and the stones and provide recommendations for their long term preservation;

- Prepare and submit application for SMC for proposed conservation treatments and relocation of stones to temporary internal storage space;
- Move symbol stones and carry out conservation treatments as recommended which are likely to include the removal of soiling and biological growth, the consolidation of areas of disaggregation against further decay and the repair of the crack on Rhynie 3 and any other fissures identified after de-soiling and removal of biological growth.

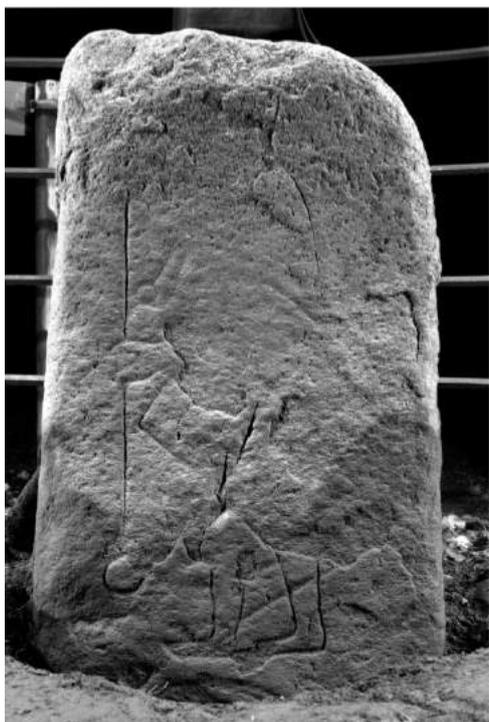
Rhynie 3 is a slightly larger granite boulder, measuring 0.7m x 0.5m x 0.3m and only faint traces of the original carving survive.

Photograph of Rhynie 3, 1995 RACHMS online photograph , <https://canmore.org.uk/collection/337028>

Rhynie 3 also has a large crack on its top and side, that could result in further significant loss of the original stone surface.

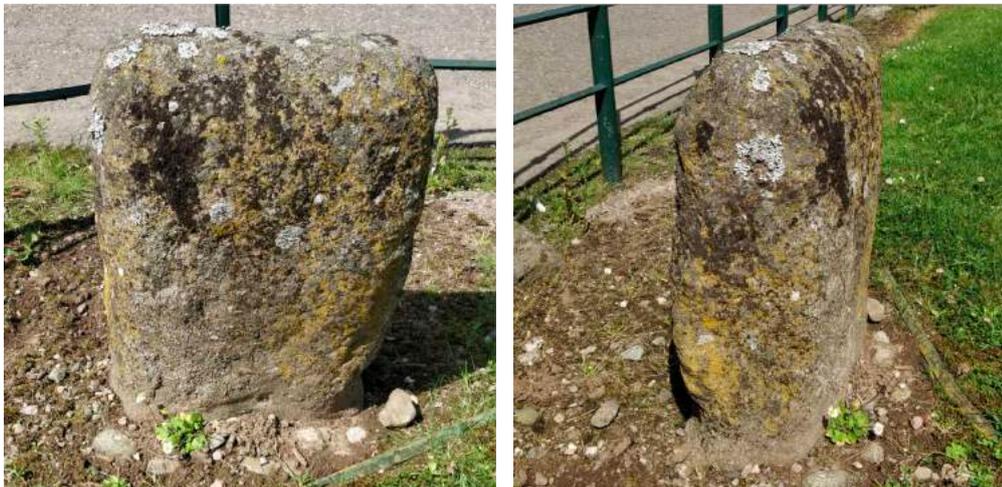
Rhynie 2. Front and Side View
Photograph 19 July, 2019

Both of the symbol stones are heavily eroded and the carved surfaces are almost obliterated. They are covered by moss, algae and lichens which obscure what little might survive of the carved surfaces.

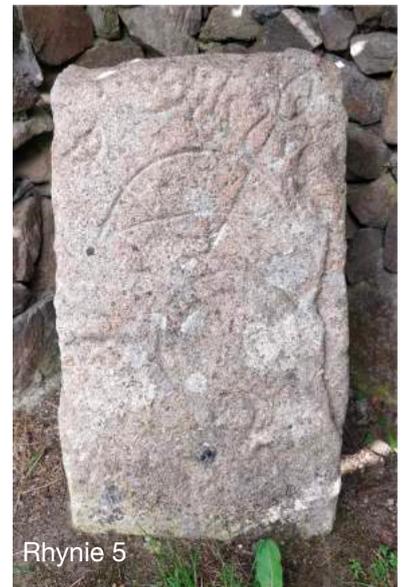
Rhynie 5 is the large whinstone symbol stone on the right hand side (rhs) of the shelter, measuring 1.6 x 0.76m. It carries the depiction of the head of a 'beast', in this case probably intended to represent a seal or otter, and a double disc and z-rod, and a mirror and comb. The stone is set into the ground with metal support brackets between the drystone wall and the back of the symbol stone.

There is some biological growth on the face of Rhynie 5, also some disaggregation of the surface and a crack or delamination runs down the right hand side of the carved face.

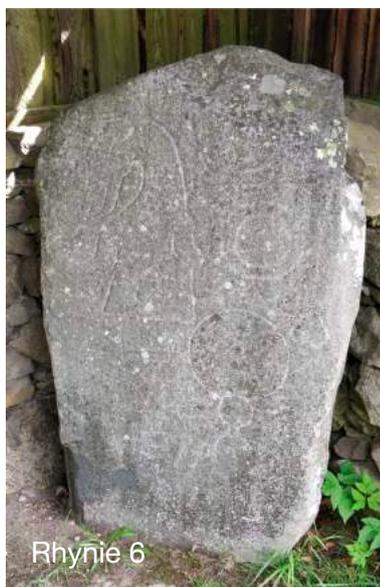
Rhynie 6 is the stone of pink granite mounted to the left hand side of the shelter, measuring 0.83 x 0.43m. It depicts 3 symbols: a vertical double disc and a z-rod, a plain crescent and a v-rod, and a mirror. The stone is also set into the ground with metal support brackets between the drystone wall and the back of the symbol stone.

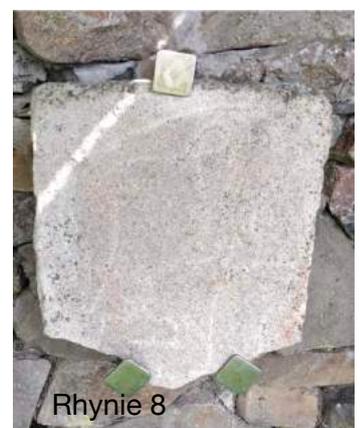
Rhynie 8 is mounted on the stone wall between Rhynie 5 & 6 and is a fragment of a larger granite block, measuring 0.43 x 0.39 x 0.16m which has been broken and squared off after the carving of the symbols on it. The symbols incised on it include the outline of a beast, surmounting a comb and a now-truncated S-shaped figure. This symbol stone is supported on two cantilevered metal tubes with a third restraining metal tube at its head.

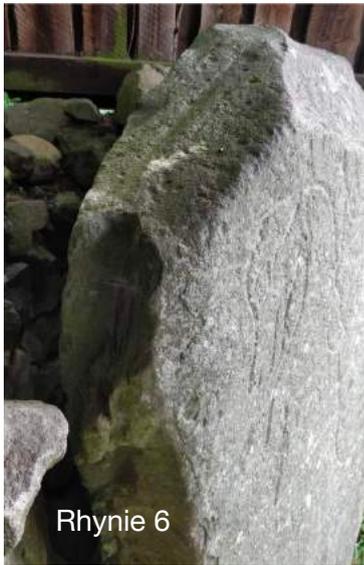
RHS: Photograph of Rhynie showing crack and disaggregation on Rhynie 5 - July 2019

- Prepare application for SMC for proposed conservation treatments and relocation of stone to temporary internal store;
- Carry out conservation treatments as recommended which is likely to include the removal of soiling and biological growth, the consolidation of areas of disaggregation against further decay and the repair of the crack on Rhynie 5 and any other fissures identified after de-soiling and removal of biological growth.

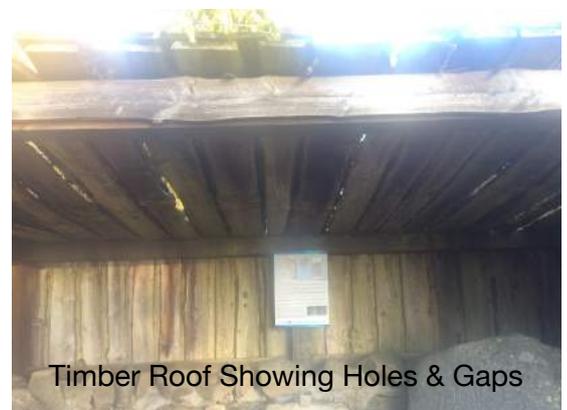
- The water run-off from the timber roof risks future decay and damage to the stones. Timber emits acetic and formic acids and preservative treatments for wood may contain copper arsenic and other soluble salts which may leach out onto the stones below; certain timbers have been found to emit significant levels of volatiles even after twenty years. The potential chemical and physical actions of soluble salts within stones in damp environments with fluctuating relative humidities can cause significant damage to carved detail on stones. If the stones are to be retained in this location in either the short or medium-long term, the existing roof structure should be repaired or replaced. The symbol stones should also be isolated from the metal support brackets.
- The stones may be at risk of theft or damage due to their isolated location.

Timber Roof Showing Holes & Gaps

- The existing roof and supporting timber structure should be repaired or replaced as a matter of urgency;
- Commission a stone conservator to carry out detailed condition survey of each symbol stone and its carved surfaces and provide recommendations for their long term preservation;

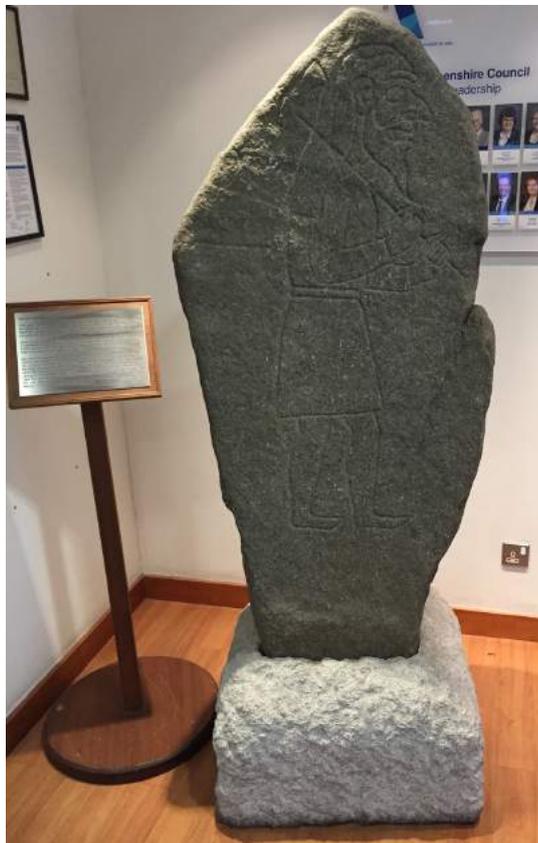
An inspection and condition survey of the Rhynie Man has not been undertaken as part of the current feasibility report. There is a large crack down the right hand side of the stone which may have been caused when it was hit by the plough.

- Commission a stone conservator to carry out detailed condition survey of the carved surfaces and the stone and provide recommendations for its long term curation;
- Relocate the Rhynie Man to an appropriate secure and environmentally stable location in Rhynie village.

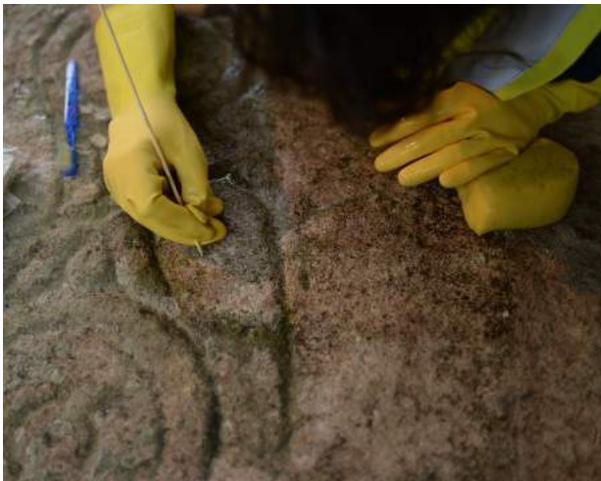
Fig. 26. Removal of soiling and biological growth on a granite Pictish symbol stone from Inverurie using wooden tools and brushes.

Soft wooden natural bristle brushes should be used for a preliminary removal of the soiling that has accumulated on the surface of stones. The moss and algae should be softened by repeatedly spraying the affected areas with water, using garden hand sprayers. Wooden tools should be used to remove the biological material to avoid any scratches on the stone surface. Any remaining biological material should be removed using a dental specification GV6 steam cleaner and small nylon bristle brushes. Regular swabbing of the surface should help prevent any dirty water run-off from soiling lower parts of the subject.

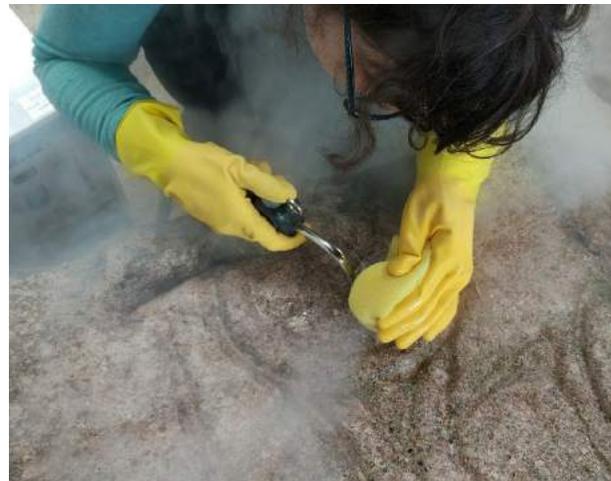
Fig. 27. Removal of biological growth and soiling of a granite Pictish symbol stone from Inverurie using a GV6 dental specification steam cleaner.

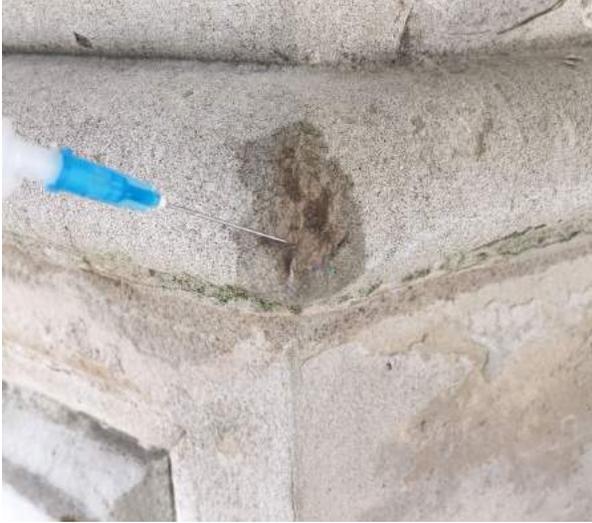
Fig. 28 . Example of consolidation of a sandstone monument using a Primal B60A acrylic colloidal suspension.

Areas of disaggregation, such as those on Rhynie 5 and any other area identified after desoiling and removal of biological growth, should be consolidated against further decay. Given their location outdoors, we would use Primal B60A, an acrylic colloidal dispersion supplied in water. Primal has a much finer particle size than other emulsions, approximately 0.03 microns, which makes it a very flexible and durable consolidant, suitable for the consolidation of old masonry and crumbling stone.

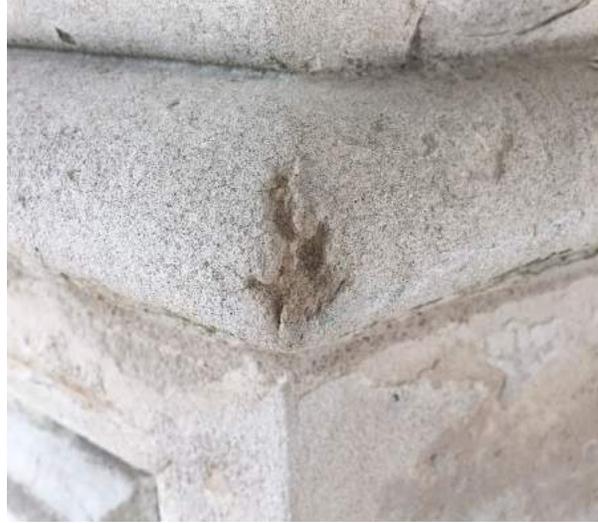
Fig. 29. The same area, after consolidation.

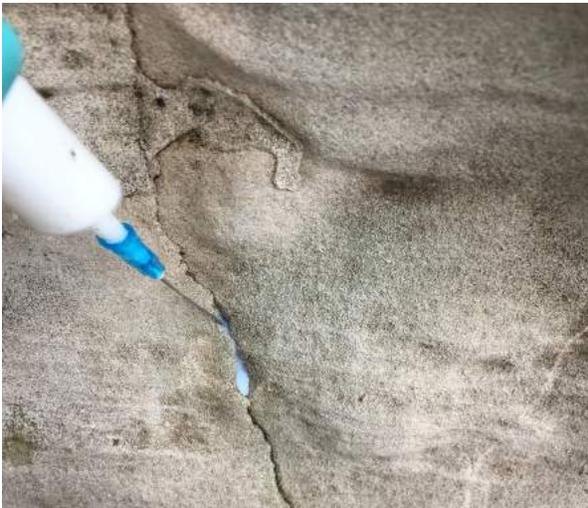
Fig. 30. View of a crack during consolidation of a sandstone monument.

Cracks up to 2mm wide should be made secure against the ingress of moisture by injecting a solution of Primal B60A in water, consolidating and preventing further water ingress. The cracks should be injected using syringes and fine hypodermic needles. Care should be taken when injecting to ensure that the consolidant penetrates into the defective area.

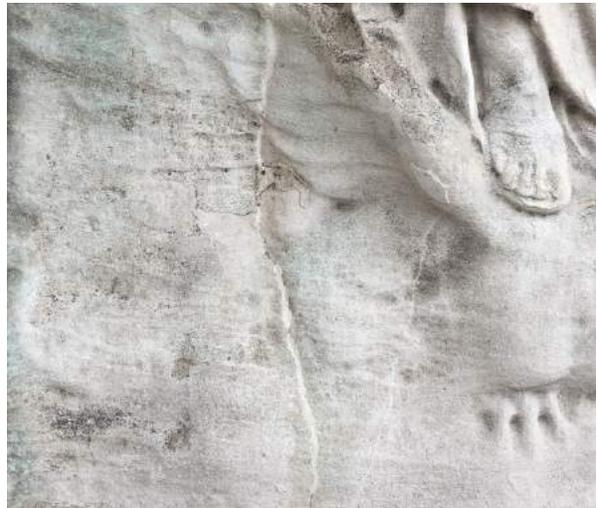
Fig. 31. View of the same crack after consolidation and filing.

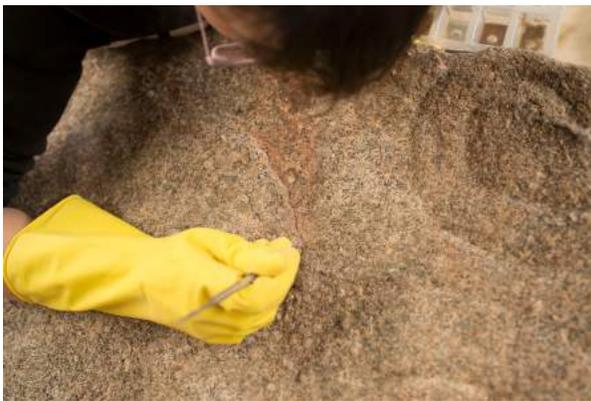
Fig. 32. Repair of a crack on a granite Pictish symbol stone from Inverurie.

For larger cracks (wider than 2mm) the area should be consolidated using an acrylic resin based repair mortar. The acrylic solution should be injected into available openings in the crack area using a syringe and fine hypodermic needle. This effectively re-adheres the detached surface to the stone substrate. In addition, an acrylic resin based repair mortar containing a very fine aggregate will be inserted into the crack and brushed into available openings. This treatment is effective in arresting continued loss of material. Wider cracks should be filled by applying a repair mortar consisting of a mix of Primal suspension in water with stone dust. The acrylic dispersion will “set” by evaporation and is reversible.

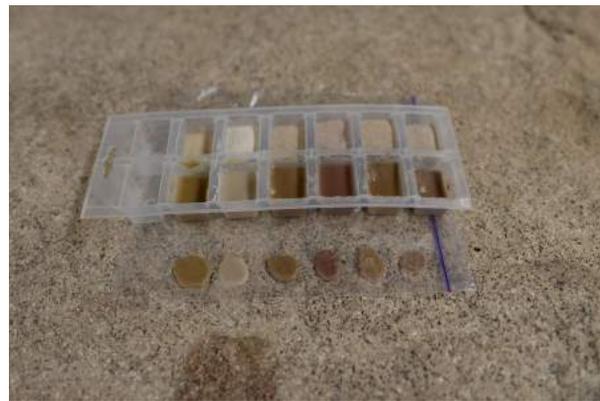
Fig. 33. Colour matching of the mortar used for repairs on a granite Pictish symbol stone from Inverurie.

Special attention will be paid to colour matching to reduce visibility of the fills with colour and opacity. Spectrum Heritage has a wide selection of hand crushed stone dust of various stone types and colours to match up any stone.

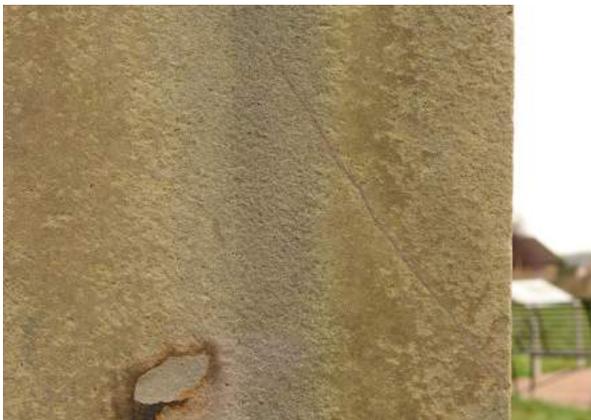
Fig. 34. Repair on Gravestone at Kirkton Churchyard, Burntisland. Water trap (Lithomex) and fissure (stone dust and Primal).

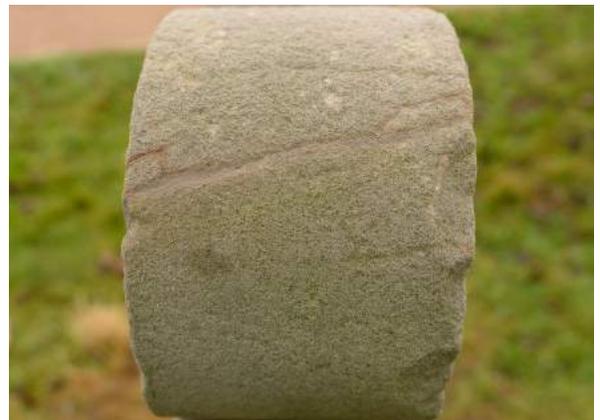
Fig. 35. Repairs of fissures on a gravestone at Kirkton Churchyard, Burntisland, carried out using a mixture of stone dust and Primal.

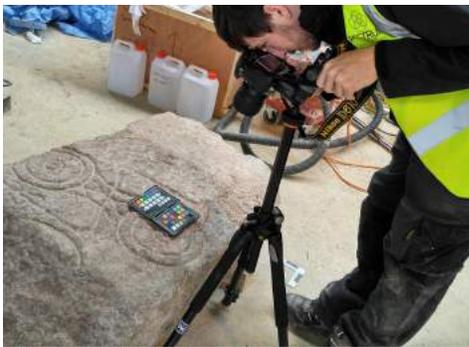
Fig. 37. Photogrammetry capture of a Pictish symbol stone from Inverurie.

Photogrammetric 3D model can be used to create orthophotos, geometrically corrected images that are really useful to observe objects in detail. These can be used to create other products, such as alteration maps showing an object's deteriorated and treated areas.

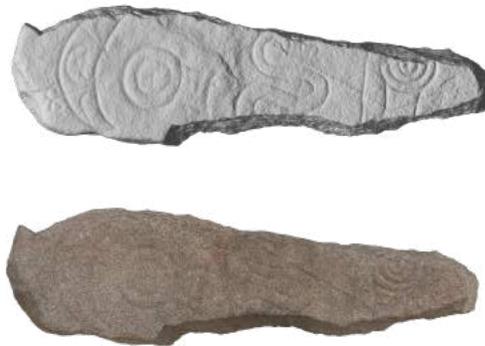
Fig. 37. Photogrammetric model with and without texture of a Pictish symbol stone from Inverurie.

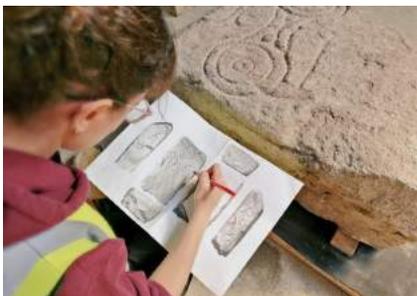
Fig. 39. Orthophotos created through photogrammetry being used to create an alteration map of a Pictish symbol stone from Inverurie.

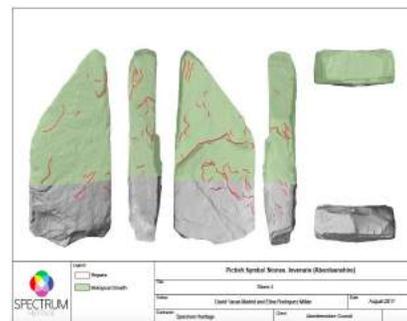
Fig. 40. Alteration map of a Pictish symbol stone from Inverurie created through photogrammetry.

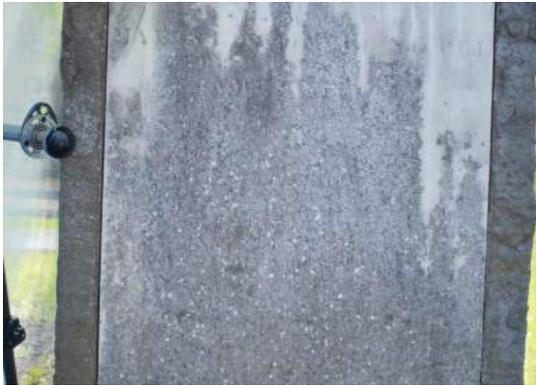
Fig. 50. Illegible gravestone before RTI. Collaboration with Archaeology Scotland and Adopt a Monument Project.

RTI, or Reflectance Transformation Imaging is a multi-image photographic technique that captures a subject's surface, shape, and colour. An RTI file is composed of a series of photographs of an artefact taken with a fixed camera and illuminated from different angles in each take with an artificial light source. Those photographs are combined into a unique file that enables the interactive re-lighting of the object from any direction. This technique is often used to read inscriptions on stone that has suffered erosion, and could help visualise the carvings of the most eroded Pictish symbol stones from Rhynie.

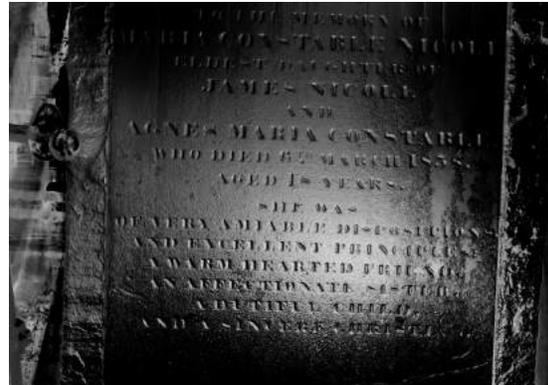
Fig. 51. RTI of the same gravestone, with its inscription now legible.

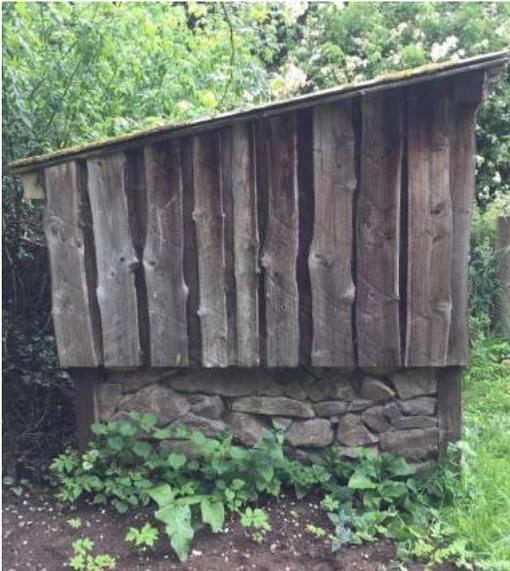
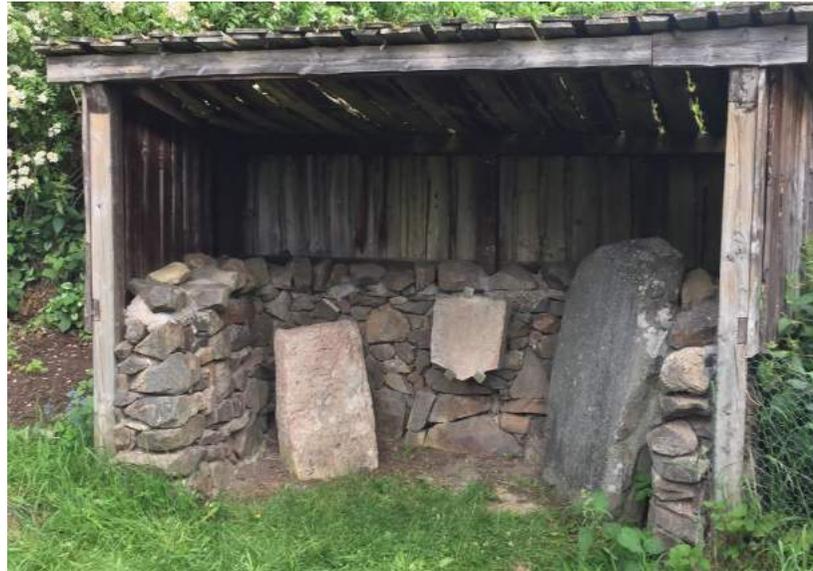
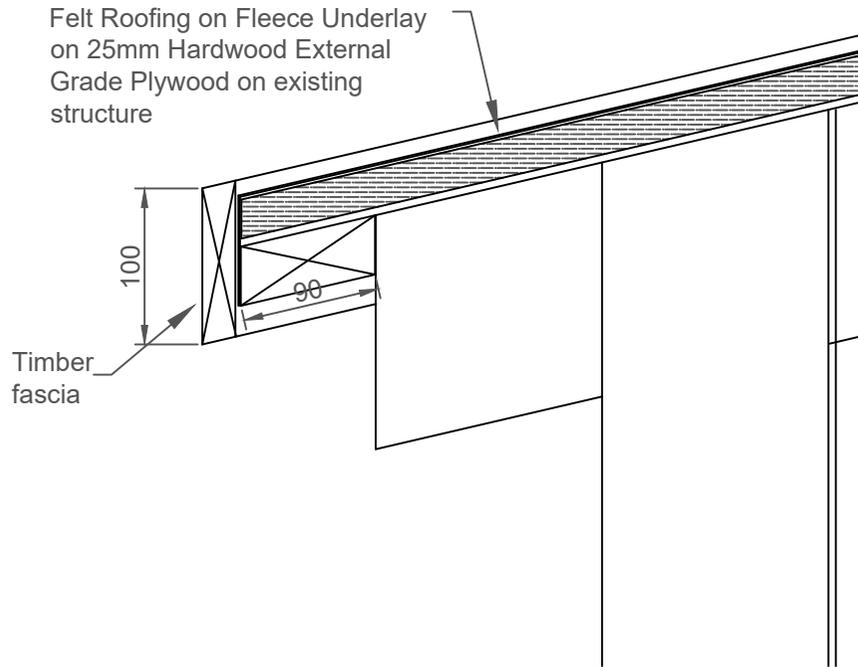
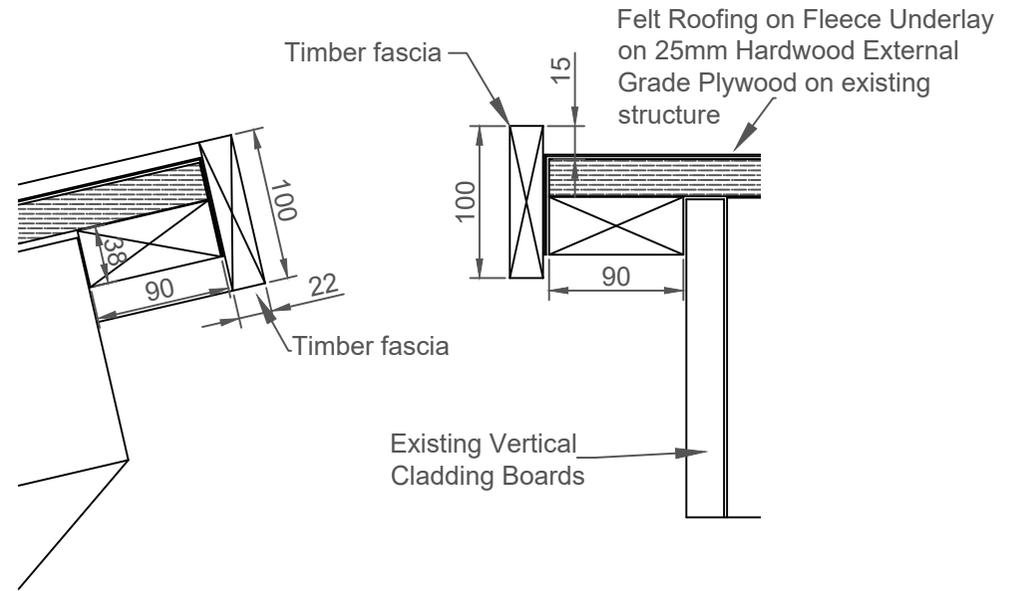
JRA Project Ref: 18/41 A_01 - Shelter Roof
Project: Rhynie Symbol Stones - Shelter

All existing cover and roofing boards to be carefully removed. Confirm that the existing roof structure is in good condition.

Staple / or nail the paper every 100mm, make sure the paper lies in flat strips that are smooth - there should be no wrinkles or spots that could catch moisture. Over lap the felt at all four edges and fix new fascia boarding.
